# HERITAGE MEADOWS

LONG TERM CARE FACILITY

RE: Heritage Meadows, Oxford, Granville County, North Carolina  
ID Number HAL039015

| {C 000} | Initial Comments<br><br>Report of a Biennial Follow Up Construction<br>Survey by Ed Miller, conducted on 10/25/2018:<br><br>Deficiencies were cited that will require a new<br>Plan of Correction. | {C 000} | | | |

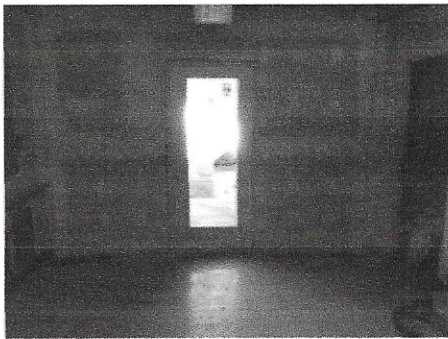
| {C 166} | Housekeeping-Maintained Free of Hazards<br><br>SECTION .0300 - PHYSICAL PLANT<br>10A NCAC 13F .0306 HOUSEKEEPING AND<br>FURNISHINGS<br>(a) Adult care homes shall:<br>(5) be maintained in an uncluttered, clean and<br>orderly manner, free of all obstructions and<br>hazards;<br>(e) This Rule shall apply to new and existing<br>facilities. | {C 166} | | | |

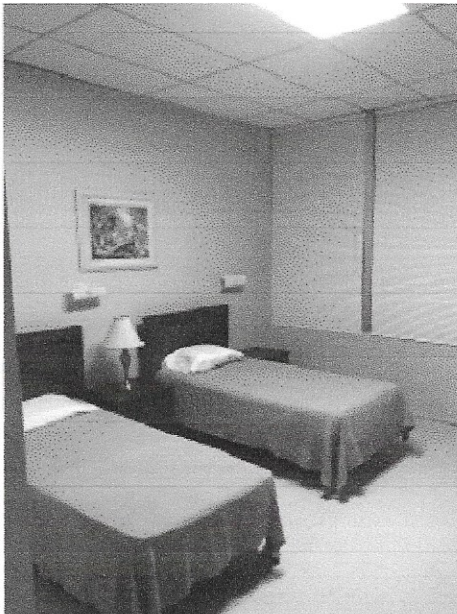
| {C 166} | Continued From page 3<br><br>This Rule is not met as evidenced by:<br>2-Based on observation, this facility has failed to be maintained in a clean and orderly manner.<br><br>Findings on 10/25/2018:<br>Most of the rubber gasket material for the exterior resident room windows is either missing or partially installed that would allow water migration into the rooms from the exterior. Based on interview of maintenance personal this work will be completed when the blinds are installed.<br><br>4-Based on observation, this facility has failed to be maintained free of hazards.<br><br>Findings on 10/25/2018:<br>The through-wall ac units for the Kitchen, have voids in the exterior wall construction due to installation and no measures were taken to prevent water from migrating into the exterior wall construction and eventually into the Kitchen interior walls. | {C 166} | Corrective Actions: C-166<br>The rubber gaskets are being replaced as we add the blinds to each room.<br>Responsible Party: Owner and Maintenance Dept.<br> | December 2, 2018 |
